(425) 652-6515  
www.Hergert.com  
Kevin @ Hergert.com  
Wa. Home Inspector 619  
WSDA Inspector 79988  
WSDA Control # 11179AQ-04

Client:  
Address:

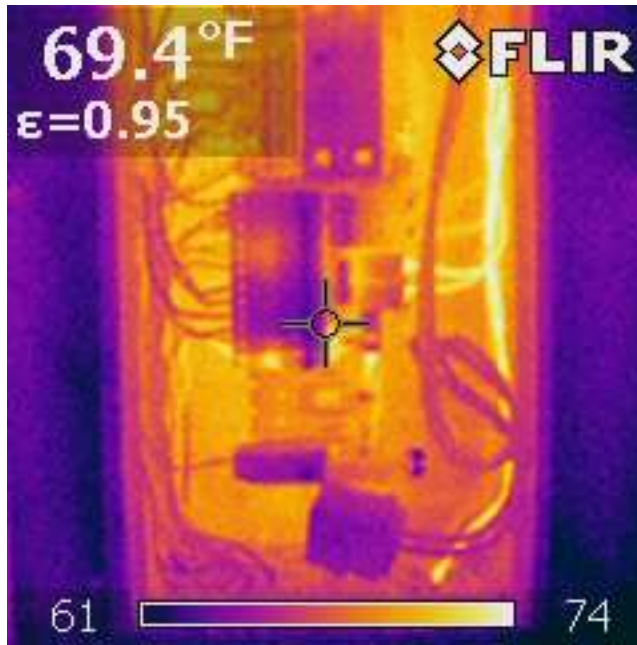
No evidence of overheating

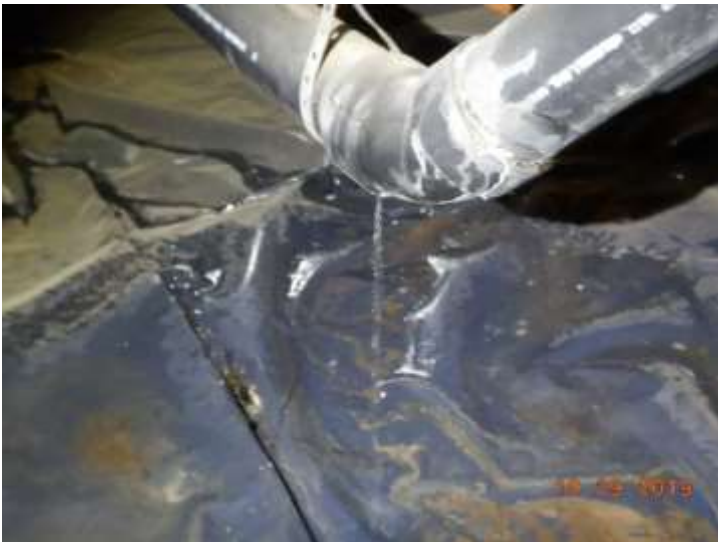
Leakage from the waste lines  
(approximately 10 feet from the front of the Living room)

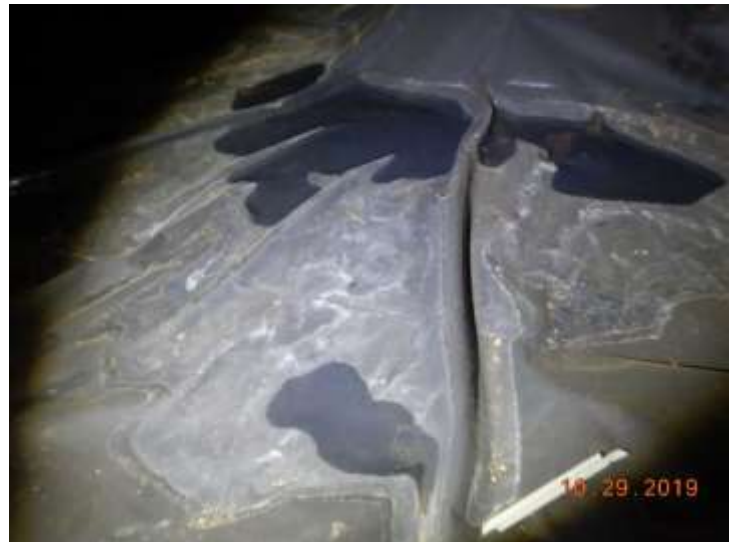
Puddles near the crawlspace access  
(below the waste lines)

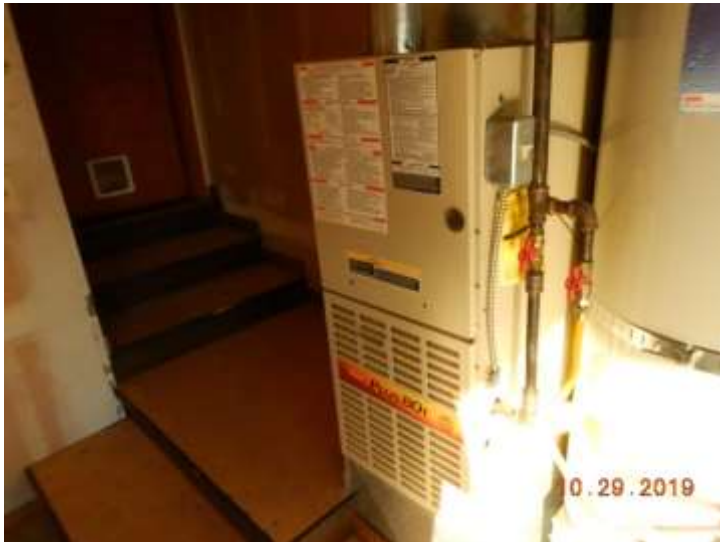
Est. Useful Life new: 25 years  
Serial number/year: 2001  
Est. age of furnace: 18 years based on the serial number  
Est remaining life: - The age of the furnace is 18 years. The remaining anticipated useful life expectancy is 7 years  
Servicing: The furnace has been serviced within the past (2) years as recommended as per the tag on the furnace  
- *The inspection of the heat exchanger involves dismantling of the components of the furnace and is beyond the scope of a Home Inspection*

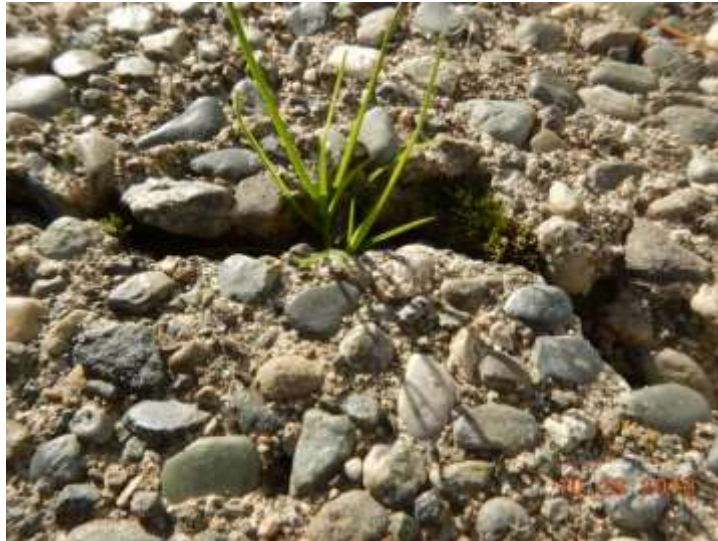
Cracks at the driveway

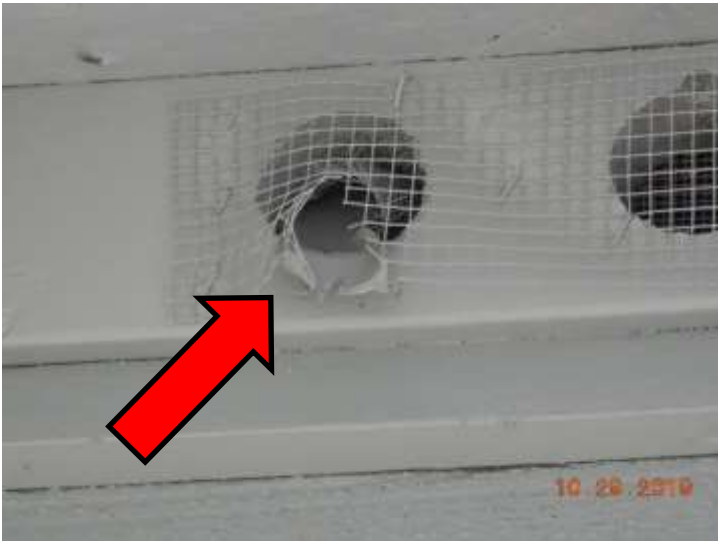
Type: Cedar  
Condition: Overall satisfactory  
Window/Door Flashing: Satisfactory  
Paint and caulking: Satisfactory  
Exterior vents: - An eave vent is torn at the front side of the garage. This damage can result in pest intrusion into the garage  
- The wood type block used at the dryer vent is not rated for exterior use. At a minimum, the top of the cut board should be painted

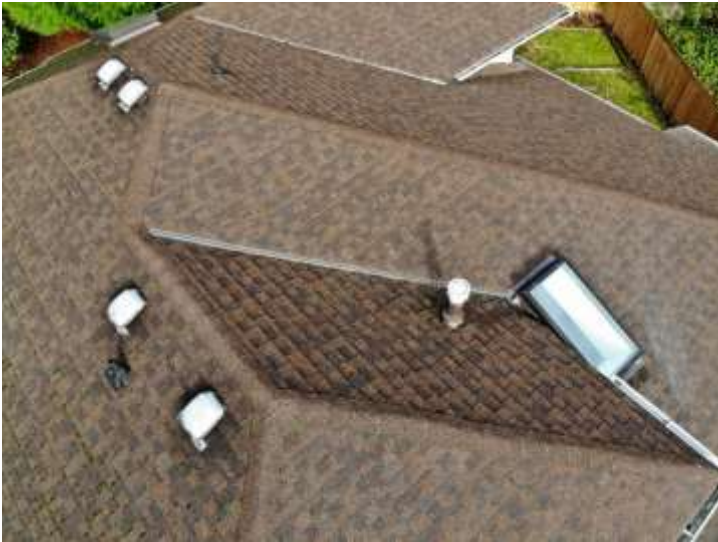
- Ventilation: Eave and roof hat vents  
Plumbing Vents: Satisfactory  
Flues: - There is substantial deterioration of the furnace flue. This deterioration could result in moisture intrusion  
Flashing: - The roof to wall metal located above the garage should be re-secured to lay flat to the roof

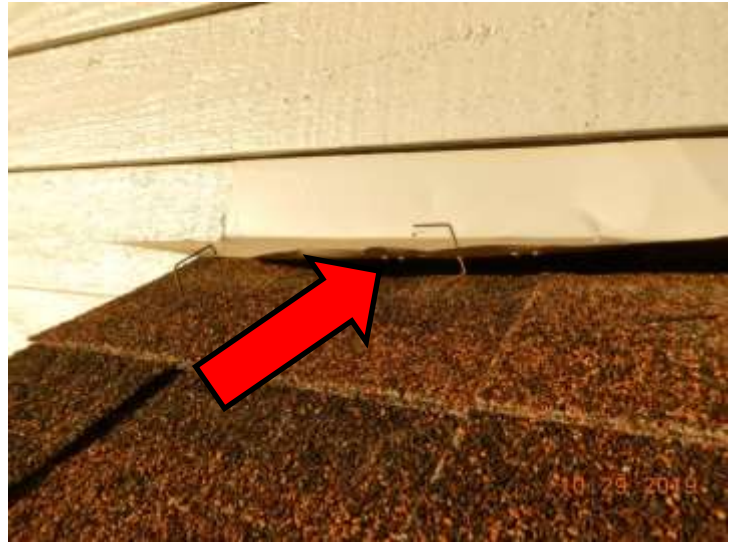
Loose roof to wall flashing

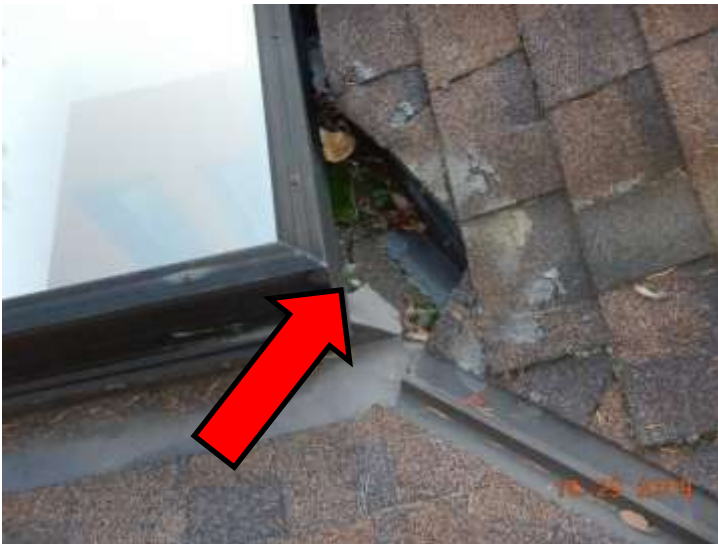
The area above the entryway skylight should be kept clean of debris

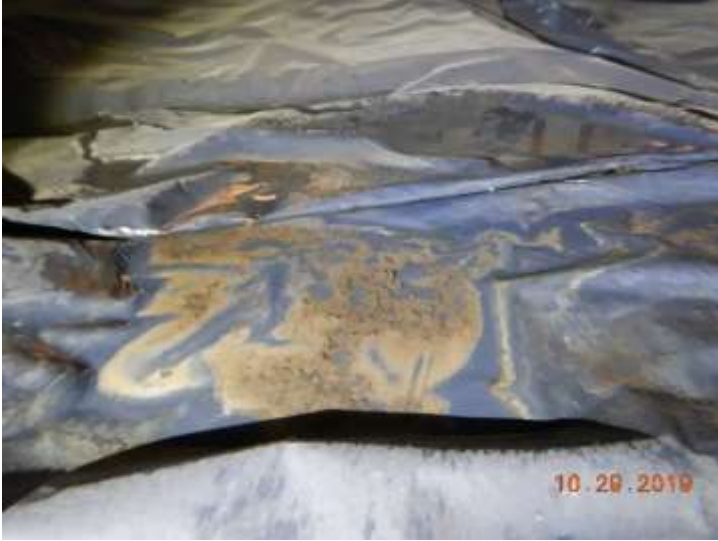
Waste water on top of the vapor barrier

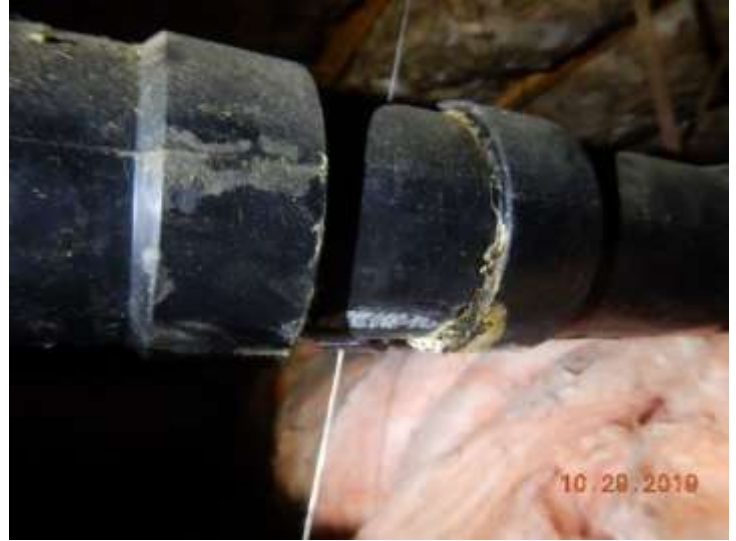
Leakage at the waste lines

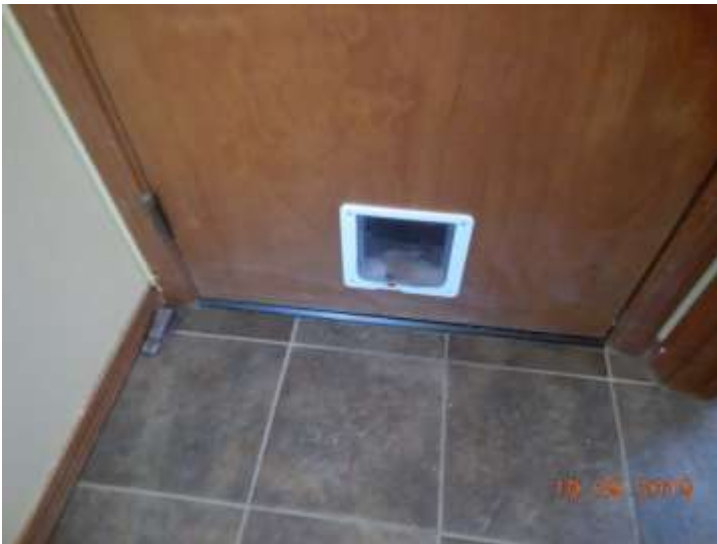
Pet door cut into the door to the garage

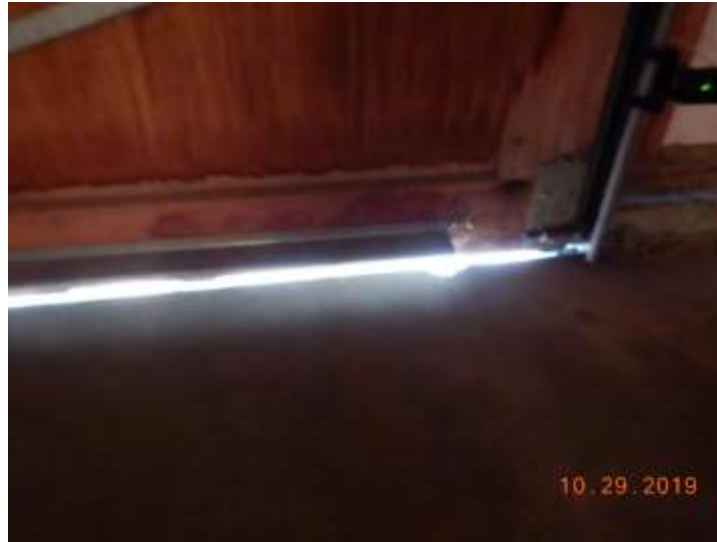
Gaps below the garage door

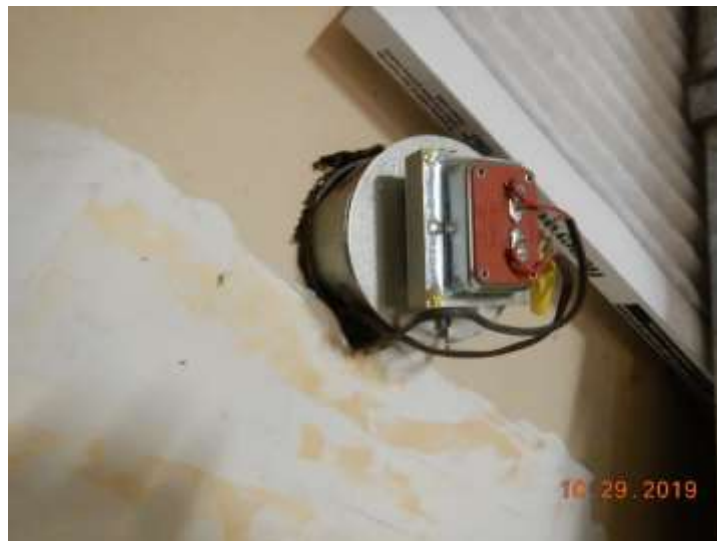
Doorbell transformer

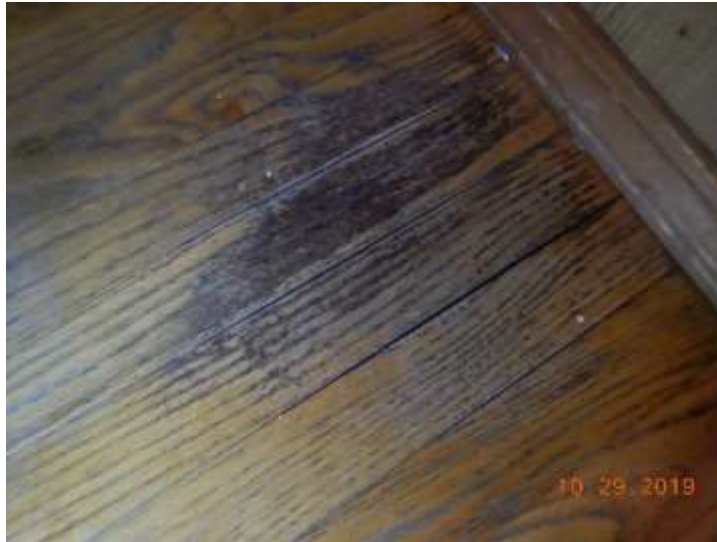
Moisture damaged hardwood floors; appears to be related to a dog water dish

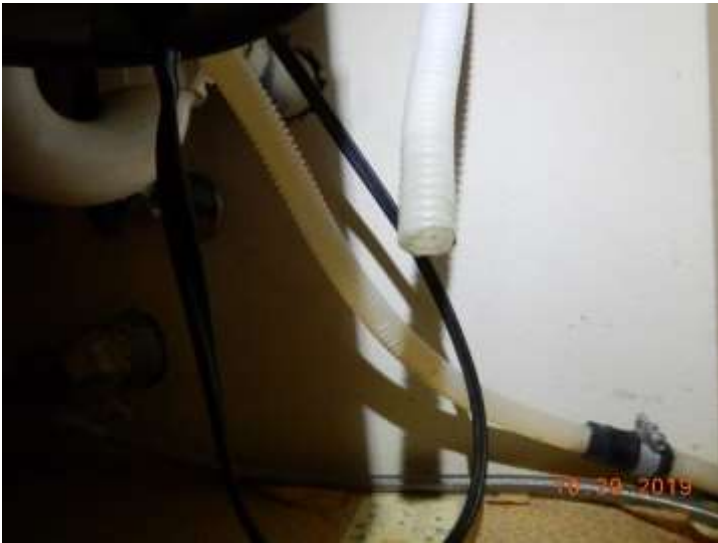
Dishwasher drain. The old air gap has been by passed

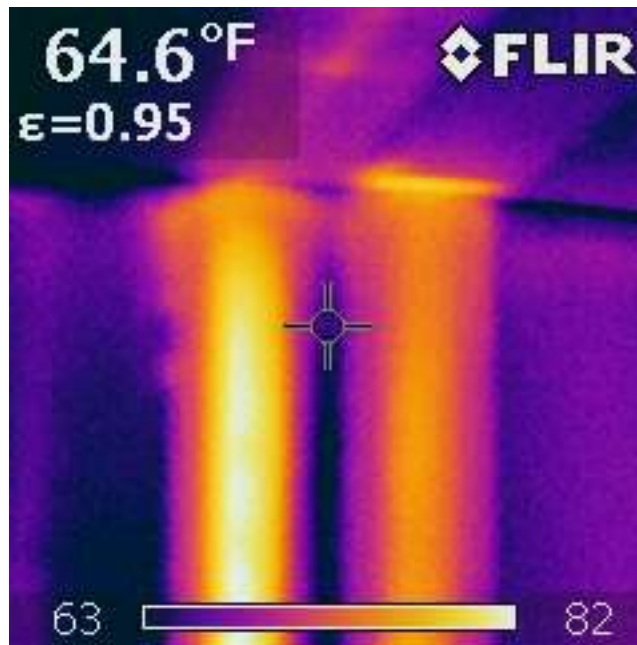
Heat stacks located inside the wall adjacent to the Laundry room

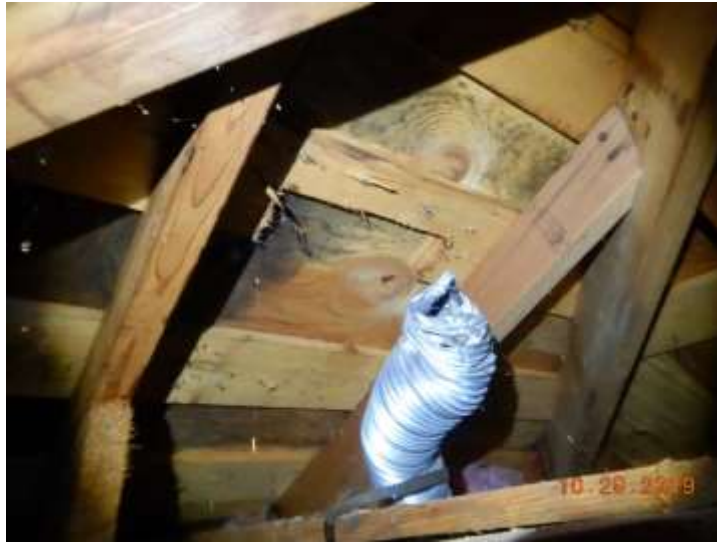
Bath fan ventilation duct does not extend to the exterior

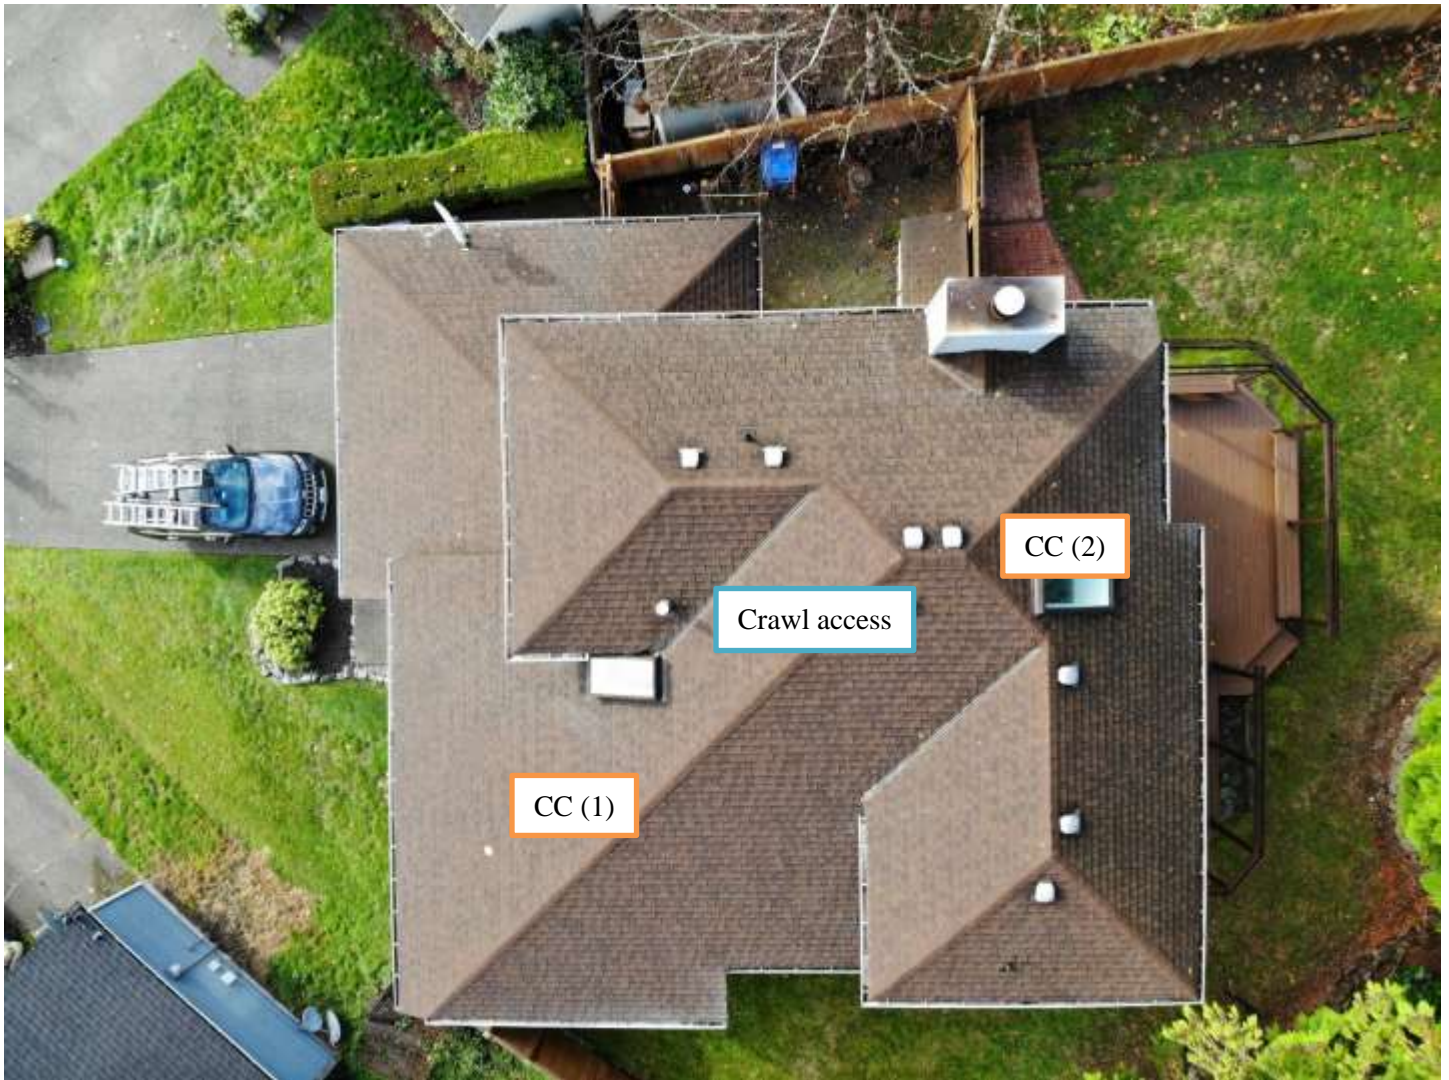
CC (1): Waste line leakage  
CC (2): Bath fan vent not extended to exterior
