(425) 652-6515
www.Hergert.com
Kevin @ Hergert.com
Wa. Home Inspector 619
WSDA Inspector 79988
WSDA Control # 11567AQ-010

Client:
Address: Lake Forest Park, WA 98155

Property Description: (2) story single family home
Estimated property age: Built 2003 per King Co.
Occupancy Status: Vacant

Inspection Date: 12/08/2021
Inspection Time: 9:30 A.M. - 11:30 A.M. +-
Weather Conditions: Overcast, 45 deg f +-

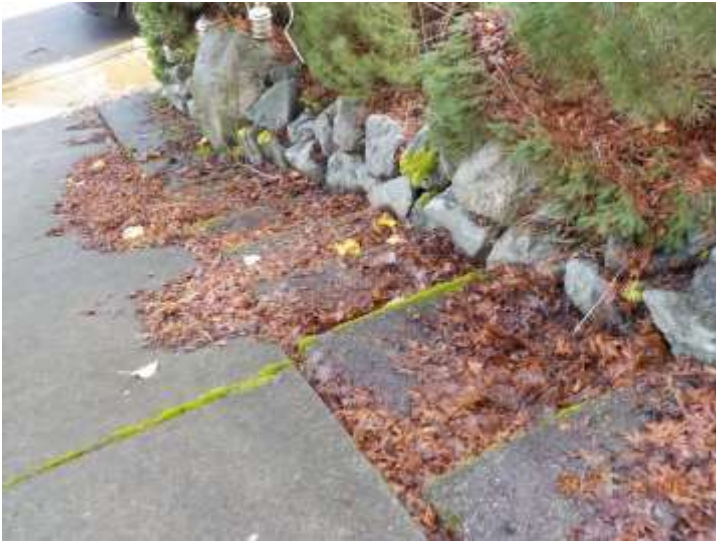
- The steps from the sidewalk to the garage are inconsistent in riser height, tread depth, and several are sloping downwards. This condition is a fall-safety hazard.

Steps from the sidewalk to the garage

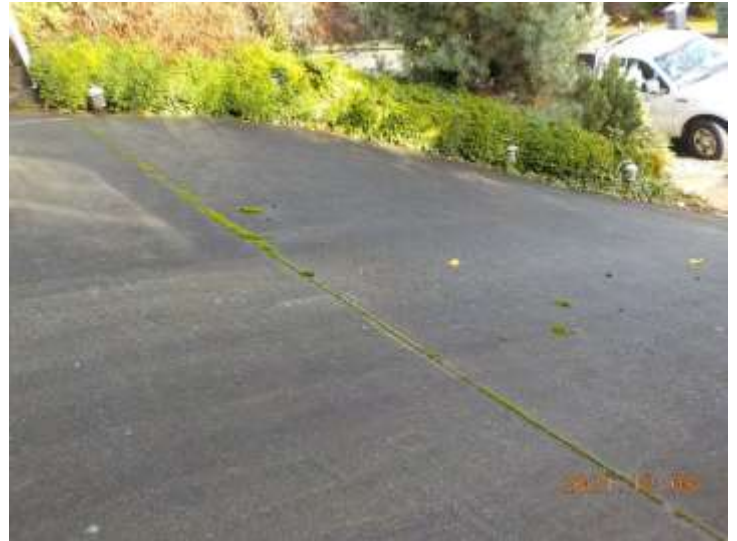
The grade of the driveway is very steep. Some cars may “bottom” out when driving from the street into the garage

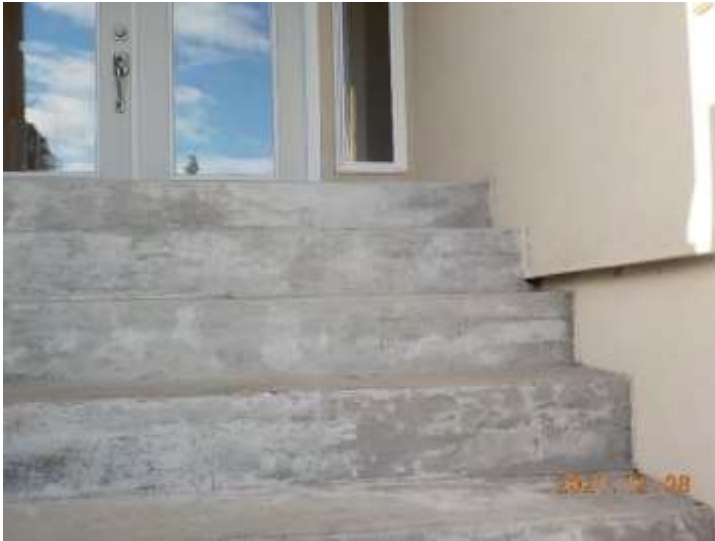
Handrails: - A graspable handrail is not installed at the upper area of the front steps as would typically be required as there are (4) or more stair risers.

A graspable handrail is not installed

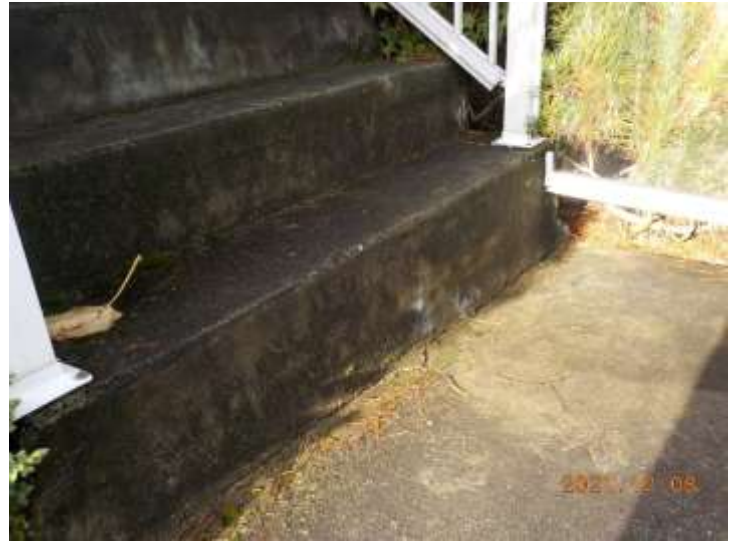
Condition: - The riser heights at the front steps are inconsistent and excessive. This condition is a fall-safety hazard. The mid area landing appears to have settled downwards to the North.

The mid landing appears to have settled

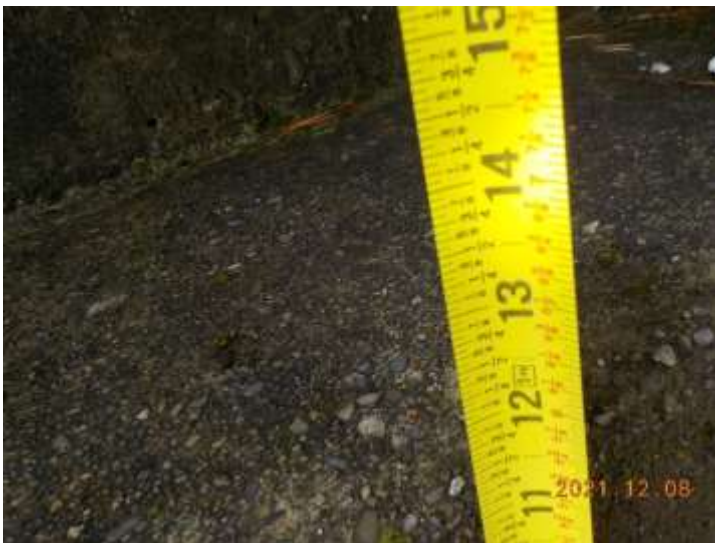
The 1st riser from the mid landing is 12" +/-

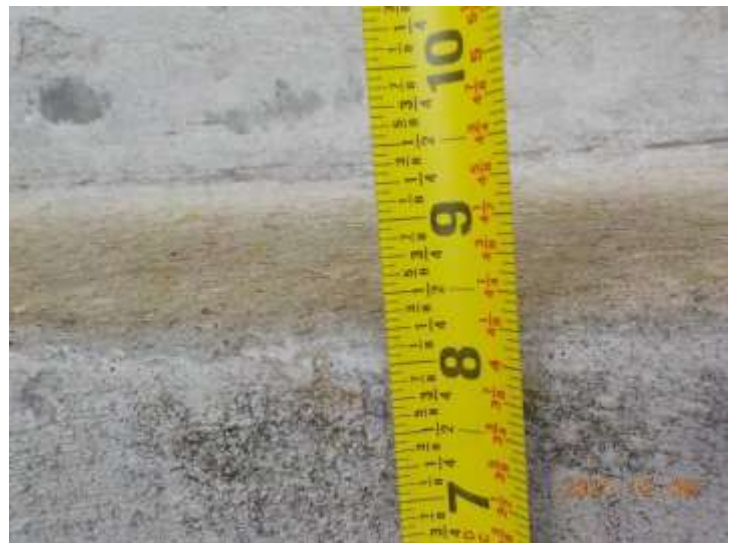
Most riser heights are > 8"

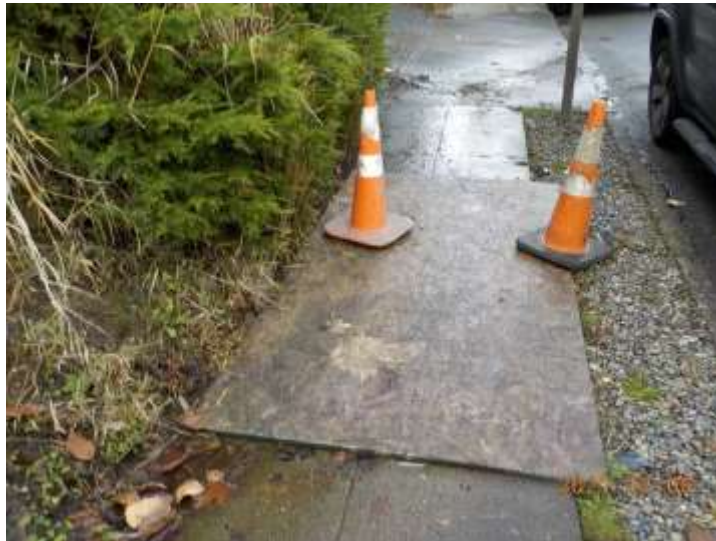
Plywood set on top of the sidewalk

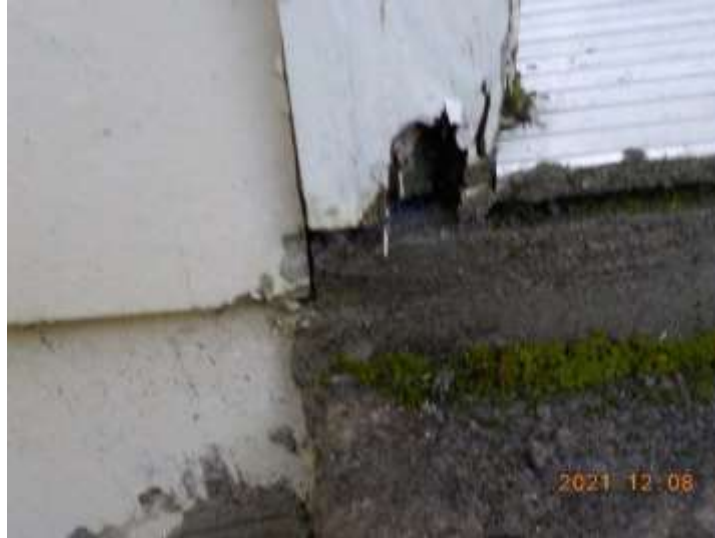
Exterior doors: - The base of the door jamb to the Dining room is rotted.

Rotted door jamb

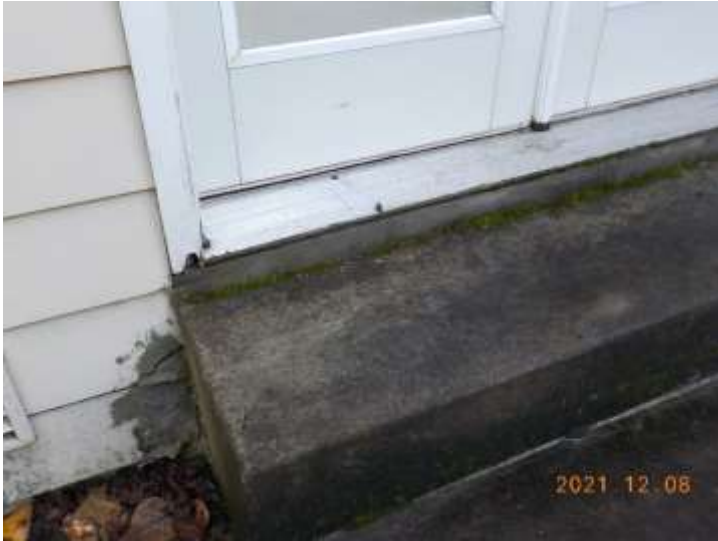
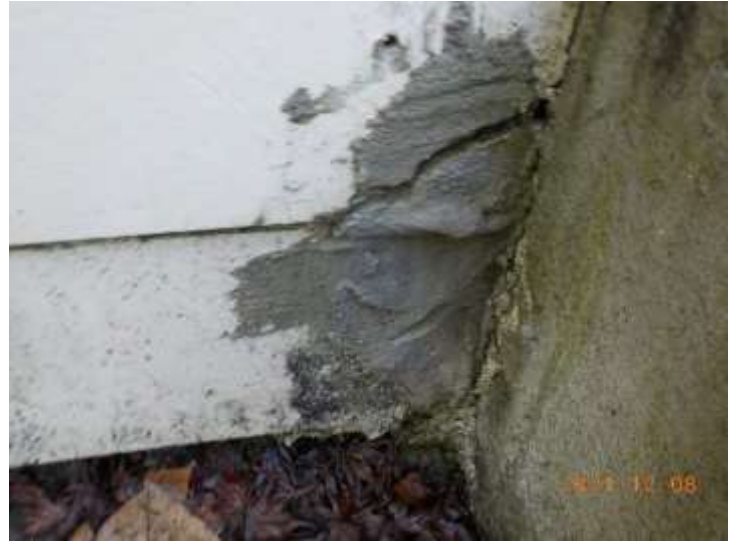
- The siding located in the vicinity of the exterior door to the Dining room is damaged. Recommend review and repair as deemed necessary by a licensed and qualified contractor.

Improper repair of the siding located adjacent to the door to the Dining room

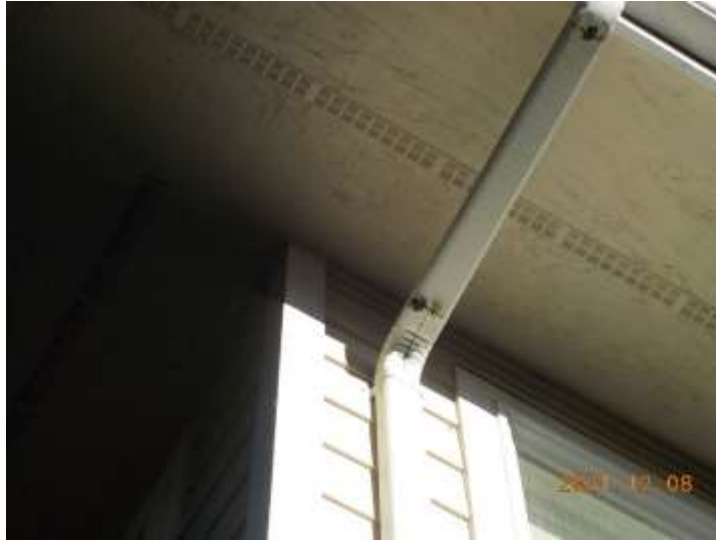
- There is leakage at downspout joints and corner joints of several gutters.

Leakage from a gutter

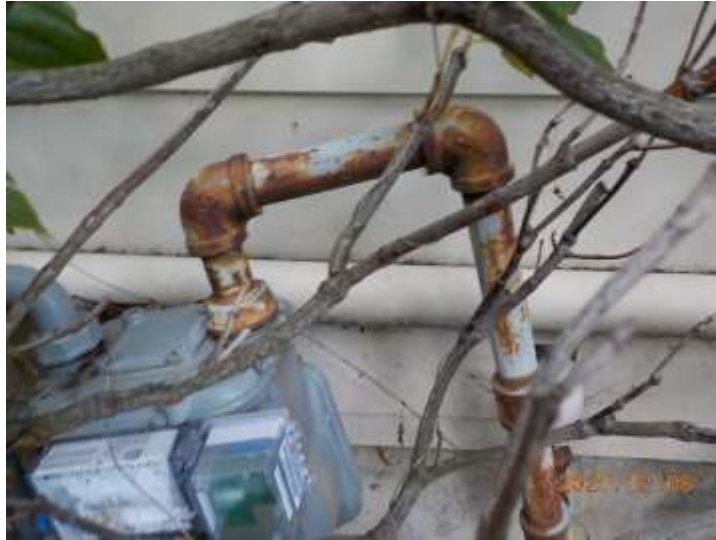
Rusting gas pipes

- The exterior gas pipes should be coated with rust proof paint.

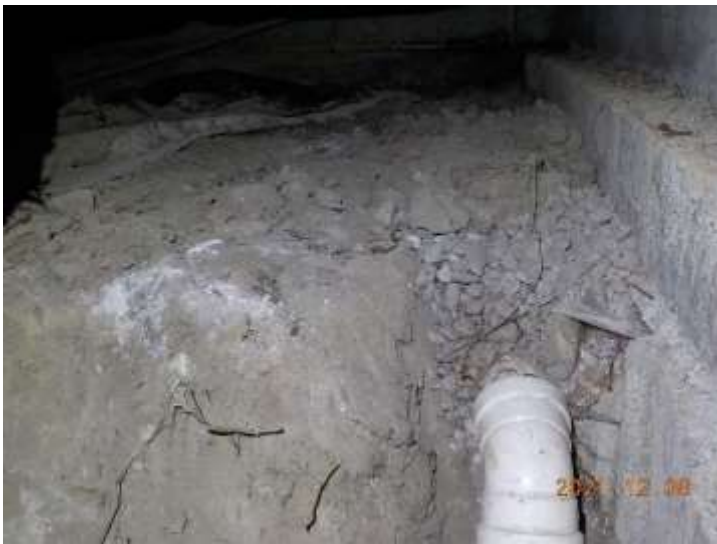
Missing vapor barrier

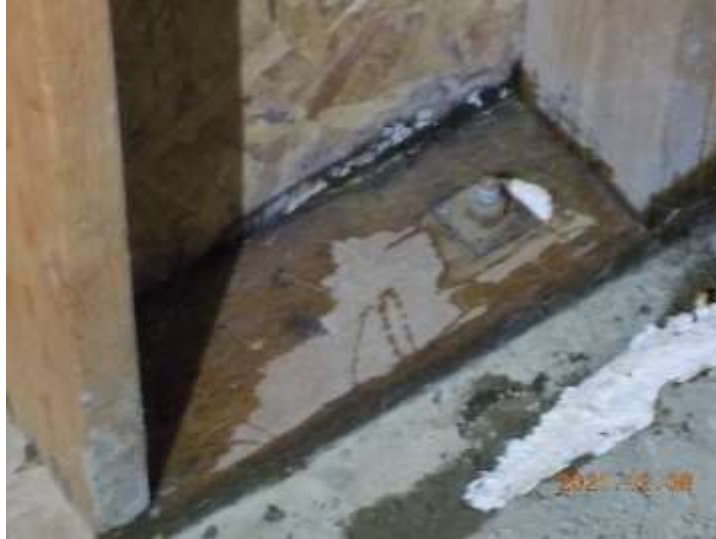
Standing water at the wall adjacent to the mechanical room. Minor wood rot is visible.

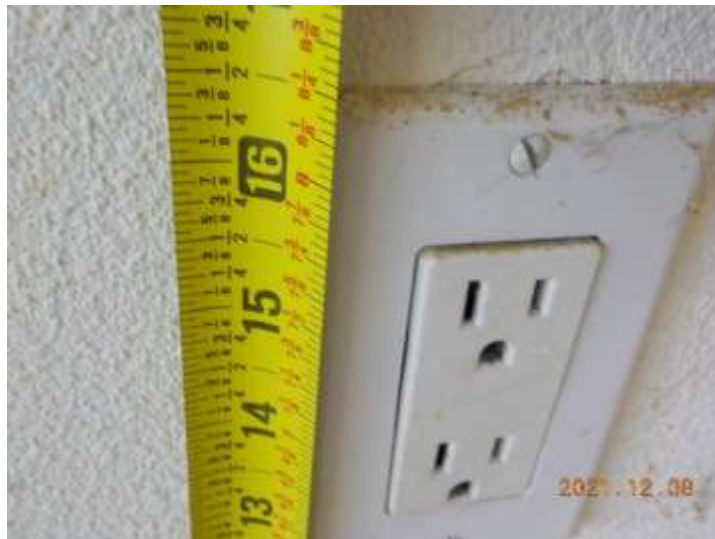
All sources if ignition should be 18" or more above the garage slab

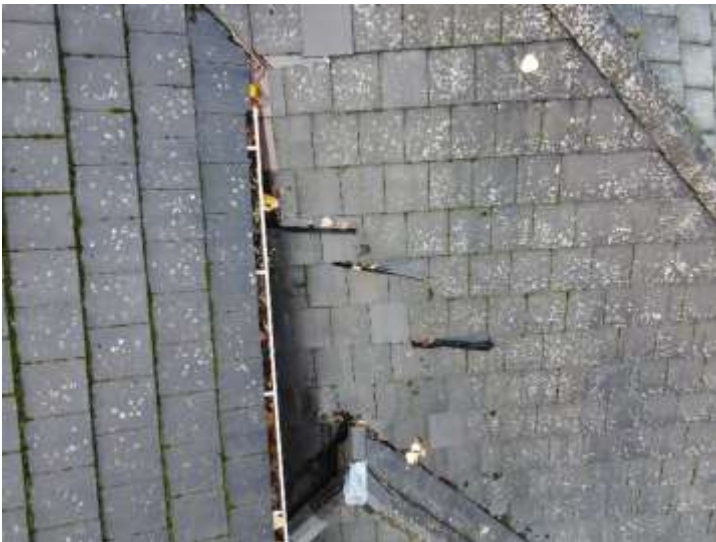
Diverter flashing is installed at the roof above the area of leakage at the S.E. corner of the Living room

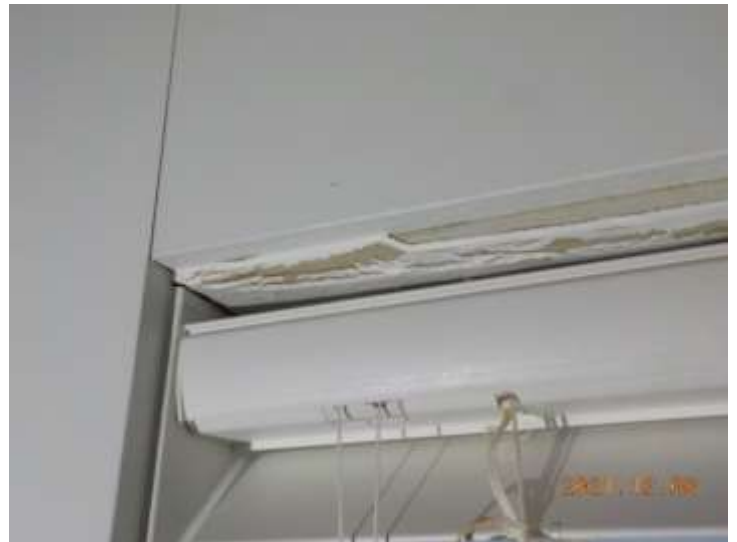
Evidence of prior moisture intrusion at the S.E. windows

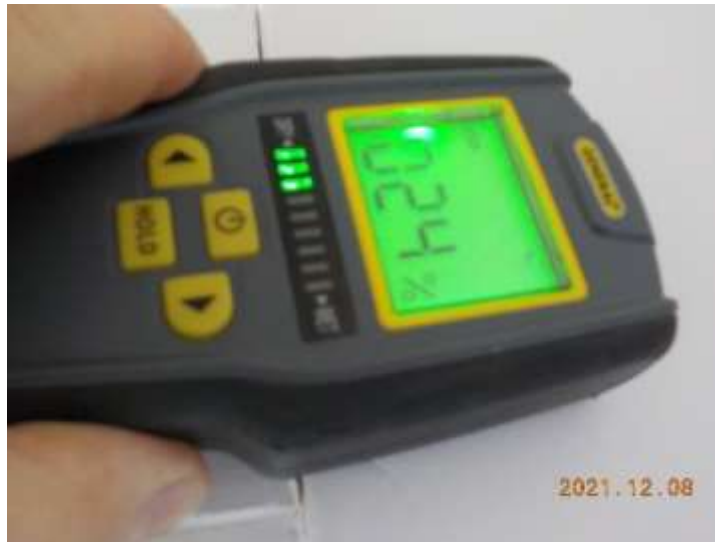
The moisture reading is slightly elevated

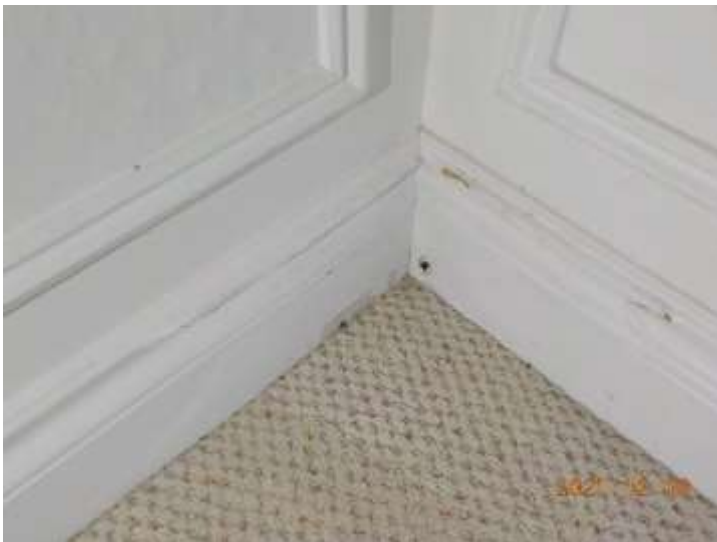
Moisture Intrusion: - There is evidence of active moisture intrusion at the N.W. corner of the Dining room. The source of this intrusion appears to be from the adjacent exterior door. Recommend review and repair by a licensed and qualified contractor.
- There is evidence of a prior moisture intrusion at the ceiling and wall area at the S.E. corner of the Living room. As the moisture reading is slightly elevated, this intrusion may be active. Recommend review and repair as deemed necessary by a licensed and qualified contractor. Note: As the siding at this area is EIFS, wood rot may exist within the wall.

Swollen baseboards at the N.W. corner of the Dining room

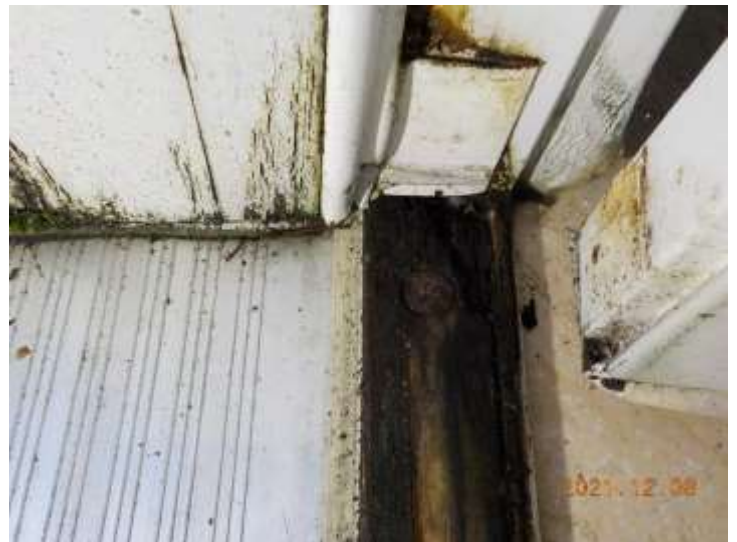
The door jamb and threshold are rotted

Door condition: - There is wood rot at the jamb and threshold of the exterior door at the Dining room. See the comments above regarding moisture intrusion.

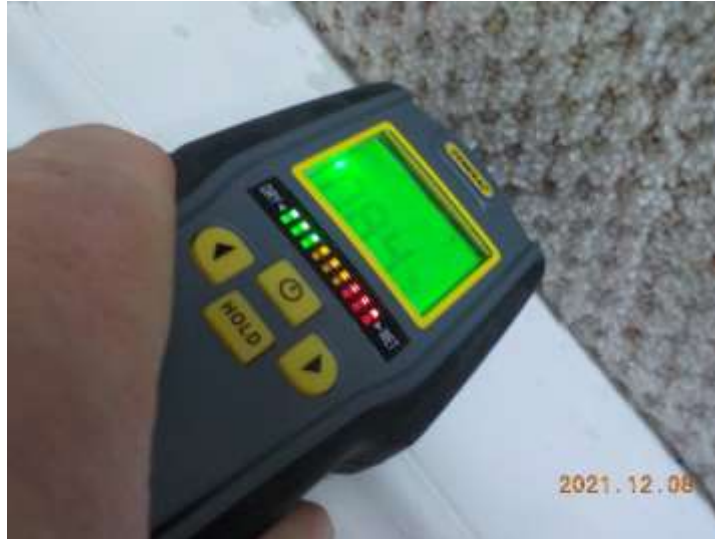
High moisture reading

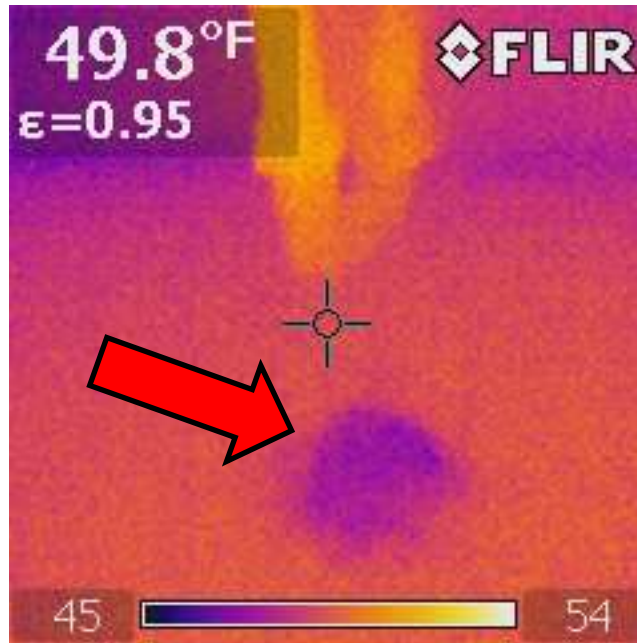
Sink(s): No substantive visible defects identified, except as noted below
- There is visible leakage from the sink into the sink base cabinet.

Leakage into the sink base cabinet

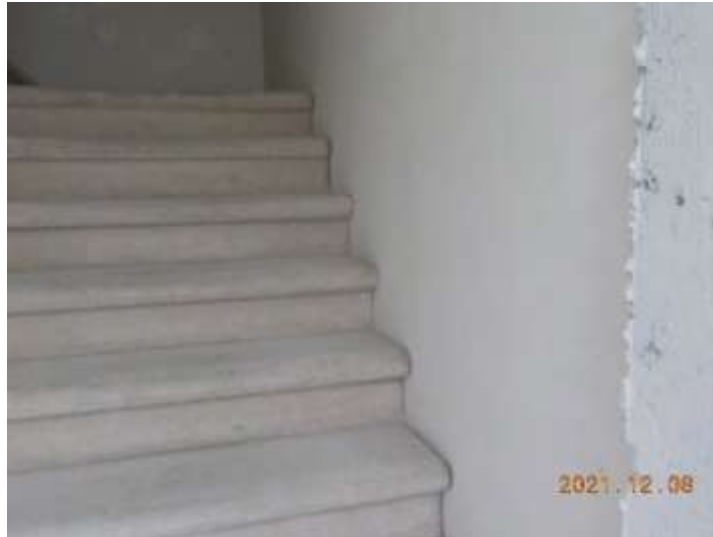
- A graspable handrail is not installed at the stairs to the garage as is typically required as there are (4) or more risers.

A graspable handrail is not installed

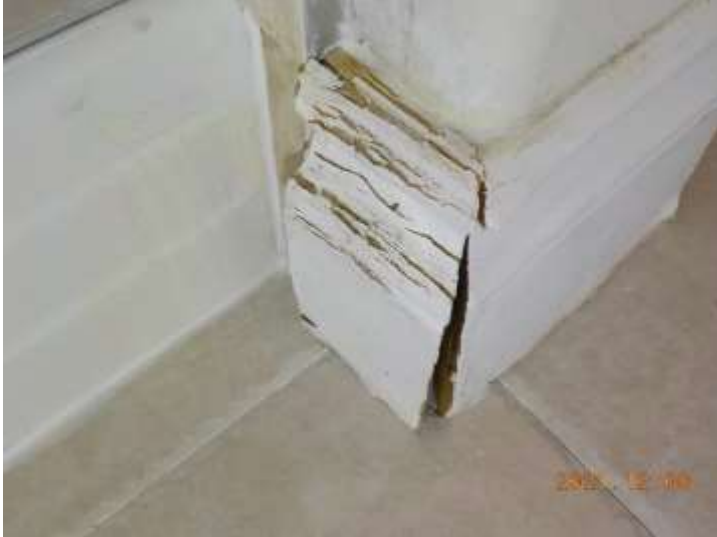
- There is substantive moisture damage to the millwork in the bathroom where adjacent to the shower. This type of damage is typically related to water splashing out of the shower. Although damaged, this item serves its intended purpose.

Moisture damaged millwork

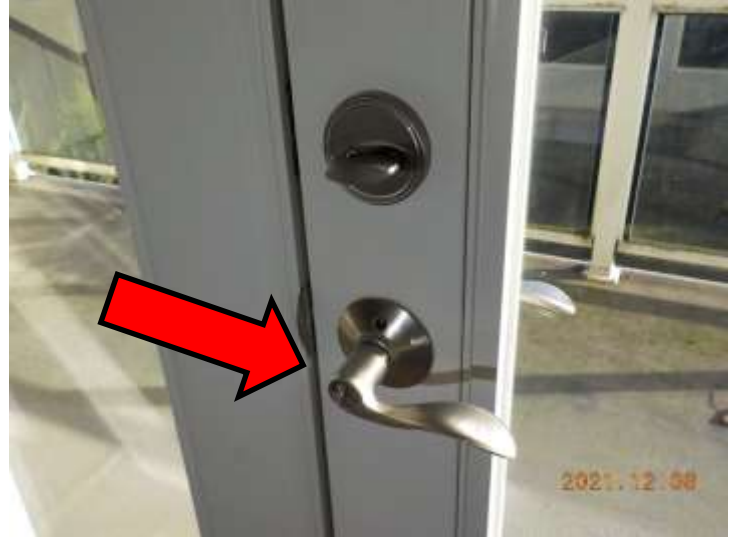
This type of lock can result in accidental lockout on the deck
