(425) 652-6515
www.Hergert.com
Kevin @ Hergert.com
Wa. Home Inspector 619
WSDA Inspector 79988
WSDA Control # 11567AQ-010

Client:
Address: Lake Forest Park, WA 98155

Property Description: (2) story single family home
Estimated property age: Built 2003 per King Co.
Occupancy Status: Vacant

Inspection Date: 12/08/2021
Inspection Time: 9:30 A.M. - 11:30 A.M. +-
Weather Conditions: Overcast, 45 deg f +-

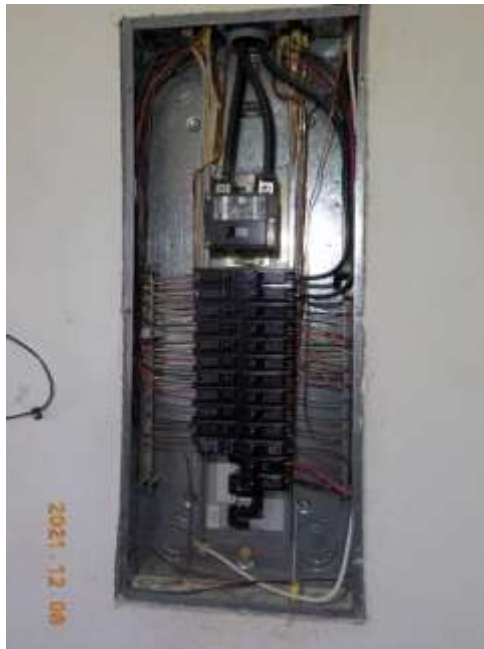
Electrical panel

Location: Garage
Manufacturer: Siemens
Type: Dual bus bar
Panel Rating: 200 AMP
Main Disconnect: 200 AMP
Serv. wire Size/ Rating: Estimated 200 AMP
Sub-panel: None located
Grounding: No visibility
Panel Clearance: Appears adequate
Panel Cover: No visible defects identified

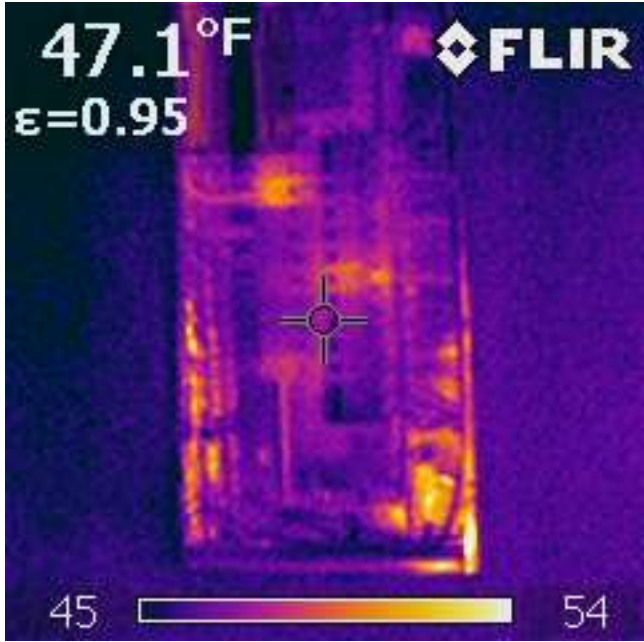
No evidence of overheating

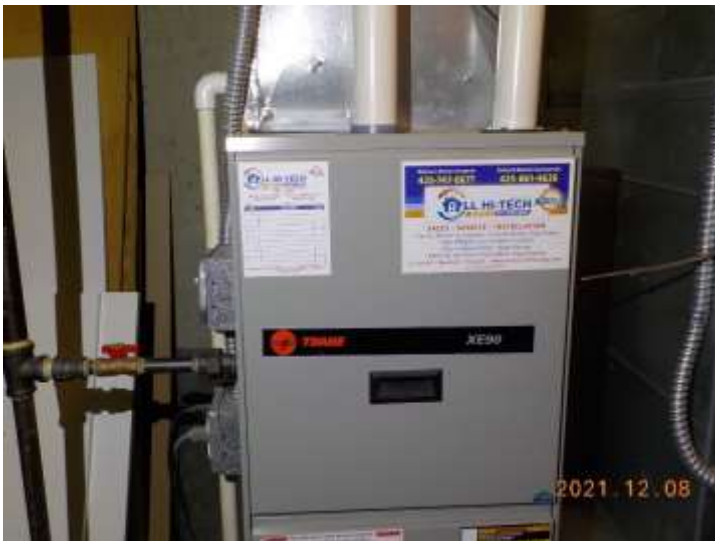
Furnace

- The age of the air conditioning system is approximately 16 years. The remaining anticipated useful life expectancy is 9 years based on industry standards.
Servicing: - Recommend furnace and air conditioning systems to be cleaned, serviced, and shown to be in good working order by a qualified HVAC technician. There is no tag on the furnace which indicates any prior servicing of the systems.

- The air conditioning system was not tested as doing so with low exterior temperatures can damage the air conditioning system.
- *The inspection of the heat exchanger involves dismantling of the components of the furnace and is beyond the scope of a Home Inspection*

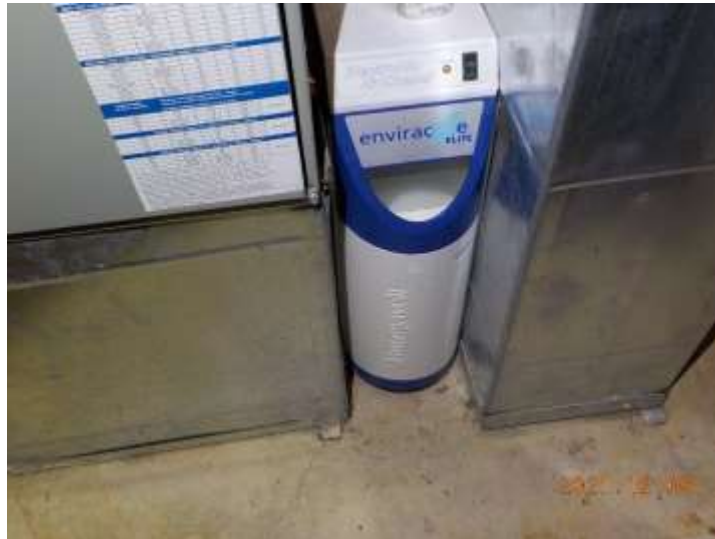
Furnace filter location

Note: The condition of the furnace filter is not a part of an inspection. A new filter should be installed when moving into the property.

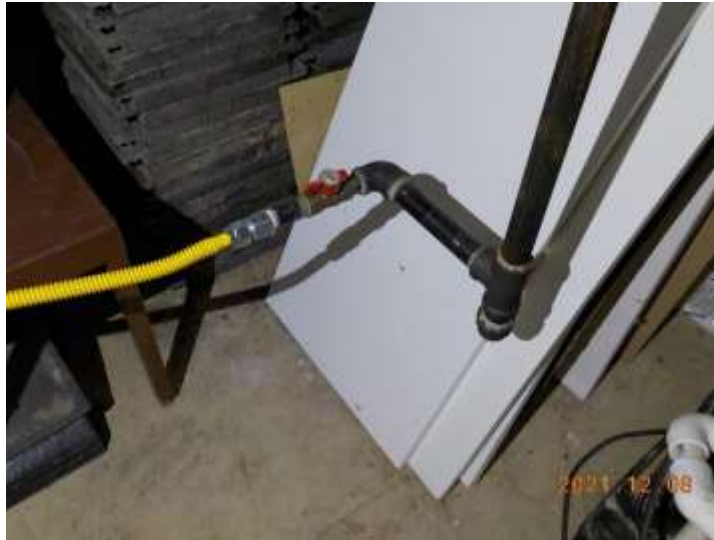
A proper gas shut off valve and sediment trap
are installed

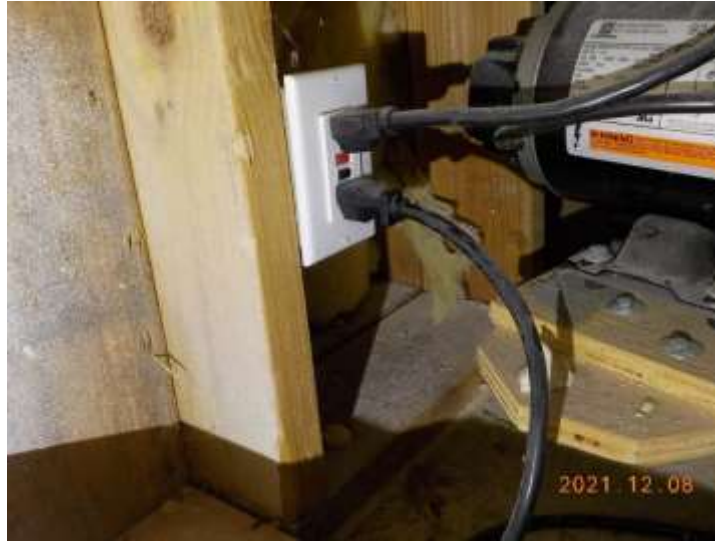
The tub motor is GFCI protected at the electrical outlet located below the tub (accessible thru the cabinet)

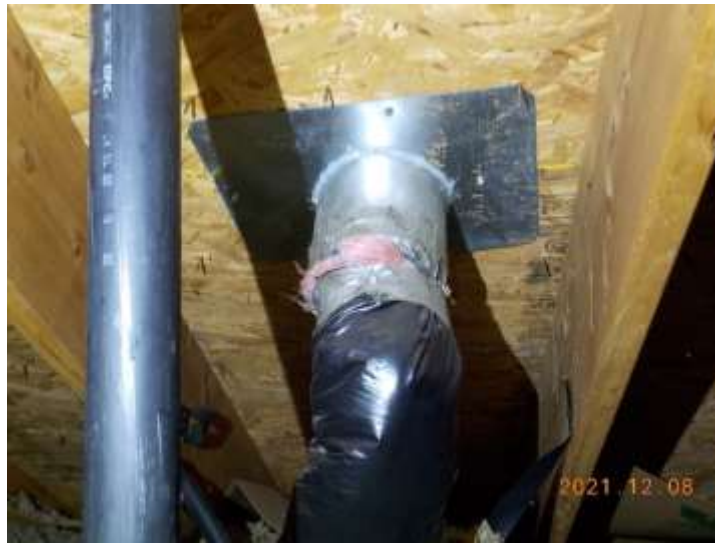
Bathroom ventilation duct (typical)

Roof Ventilation: Appears adequate
Moisture Intrusion: No visible evidence identified
Bathroom Vents: All vent to the outside where visible (limited visibility)
